Manhole Inspection Summary

Manhole # S71E1_002MH

Insp Date: **2/14/08 9:34 AM**

Location Address: **6522 Parnell Ave.**

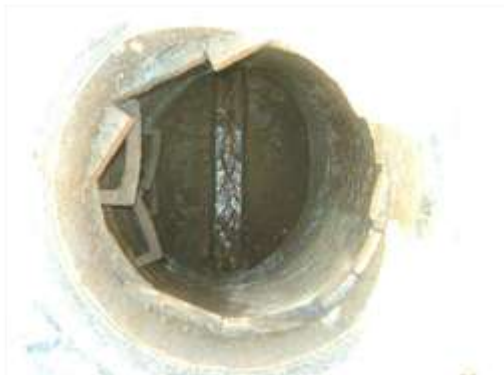
Defect 2

Condition: ☐ Sound ☐ Cracked ☐ Root Intrusion ☒ **Loose Brick** ☐ Deteriorated

Infiltration: ☐ None ☒ **Joint** ☐ Cracks ☒ **Mortar** ☐ Roots ☐ Wall

loose brick in frame adjustment 2 o'clock to 12 o'clock.

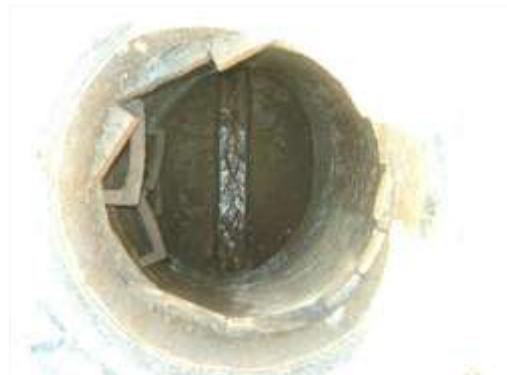
Defect 1

Frame Offset: **0** (in.) Condition: ☒ Sound ☐ Cracked ☐ Leaks

frame offset defect-2 in. loose bricks

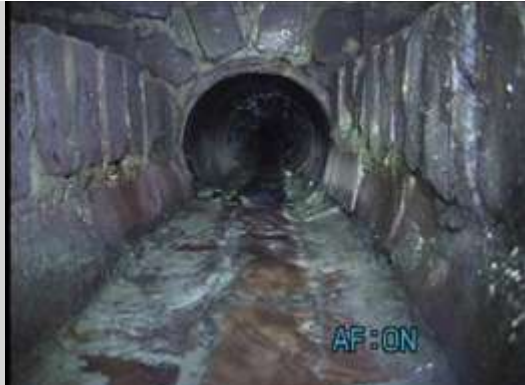
12 O'Clock Outflow

8 in. Circular Gravity Sewer
Pipe Out @ 12 O'Clock

Pipe Height: **8.4** (in.) Rod and Bar (Angled)

Pipe Material: **Clay** ☐ Pipe Lined

Invert Depth: **8.71** (ft.) Flow Characteristics: **Slow**

Deposits: ☒ None ☐ Mud ☐ Sludge ☐ Debris ☐ Grease

Infiltration: **None** Pipe Seal Cond: **Sound**

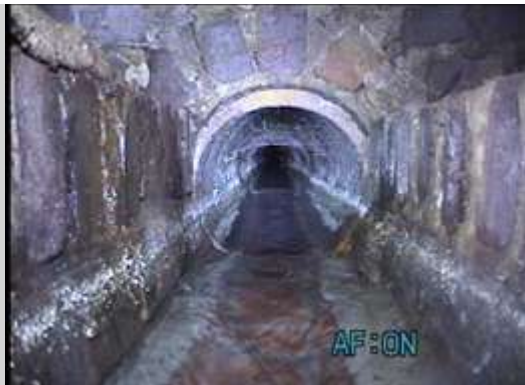
6 O'Clock Inflow

8 in. Circular Gravity Sewer
Pipe In @ 6 O'Clock

Pipe Height: **8.4** (in.) Rod and Bar (Angled)

Pipe Material: **Clay** ☐ Pipe Lined

Invert Depth: **8.58** (ft.) Flow Characteristics: **Slow**

Deposits: ☒ None ☐ Mud ☐ Sludge ☐ Debris ☐ Grease

Infiltration: **None** Pipe Seal Cond: **Sound**
